TANK CLEANING REPORT

CLEANING OF FIVE (5) VESSELS AND SUMP TANK

AT
WEST AFRICAN GAS PIPELINE COMPANY
(TAKORADI)

DATE: 21ST JULY – 24TH JULY, 2020

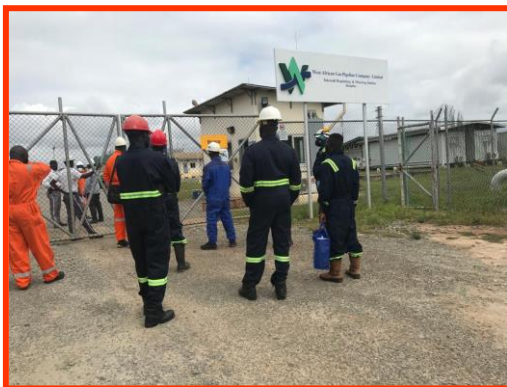
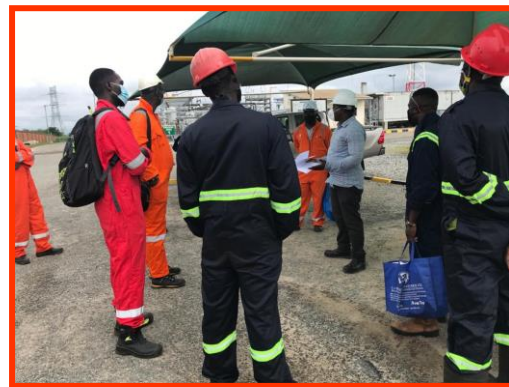
- Arrival of Bidi Group personnel to cleaning site at WAPCo.
- Safety Induction and inspection of PPE by client.
- Issuance of General Work Permit to begin work.
- Toolbox meeting with authorized personnel of WAPCo and Bidi Group Team.
- Inspection of the various vessels and tanks designated for cleaning was done. The appropriate areas to position truck and equipment was ascertained.

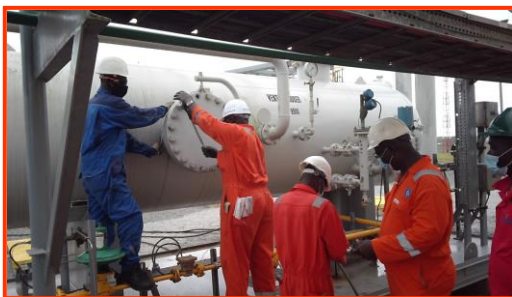
VENT SCRUBBER

- Holding of tool box meeting among Global Calibration technicians, Bidi Group Technicians and WAPCo personnel was conducted.
- Truck was positioned and the necessary equipment were offloaded.
- Work begun on the Vent Scrubber. Very thick and semi solidified material had deposited in the tank and had a depth of 8cm at the gate. There was an entry by Bidi Group Technicians to evacuate debris and solidified sediments.
- The pressure washer was used to introduce a high pressure water and degreaser mixture into the tank.
- The pressure washer was also used to unclog stuck sediments from the outlets, nipples and check valves.

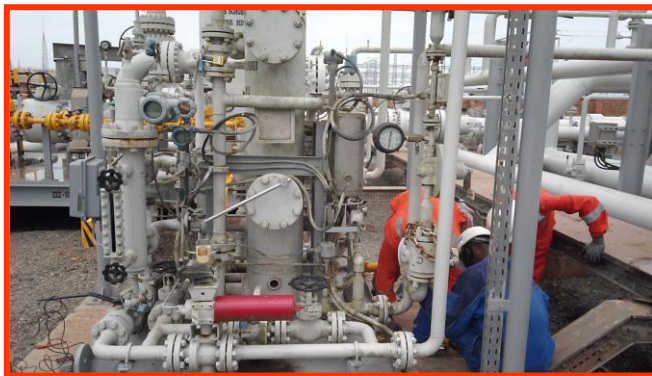
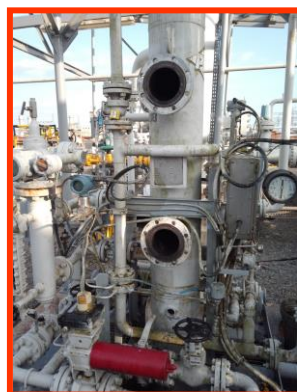
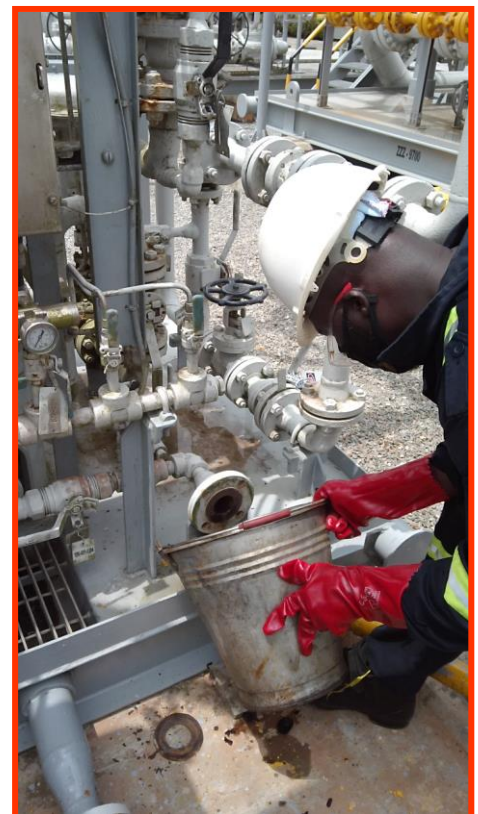
FUEL GAS SCRUBBER

- Same procedure for cleaning the vent scrubber was used to clean the fuel gas scrubber which had little sludge in it. It also had blocked lines as well which were declogged.
- The team also started work on the first filter separator. All the filters in the vessel were clogged and removed for disposal.
- Dried and caked material in the filter separator were also removed and cleaned with the pressure washer. This was however not inspected by the API Inspector.
- The necessary paper work were signed and the team left work area awaiting continuation of work the next day.

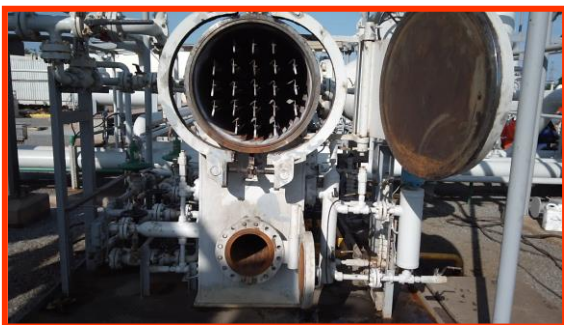
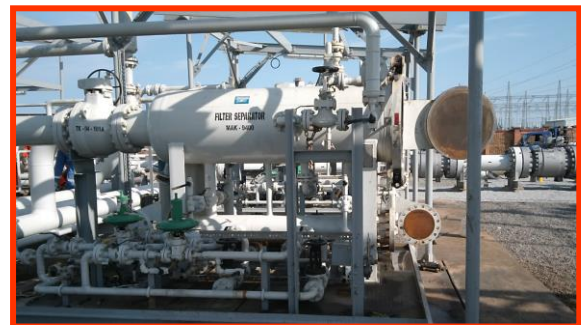
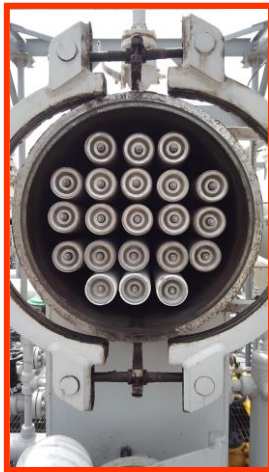
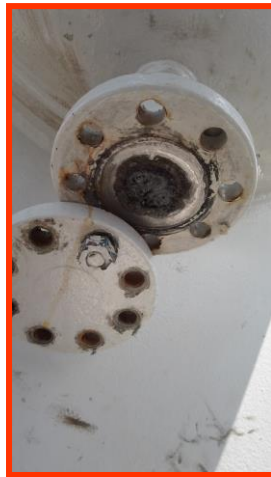
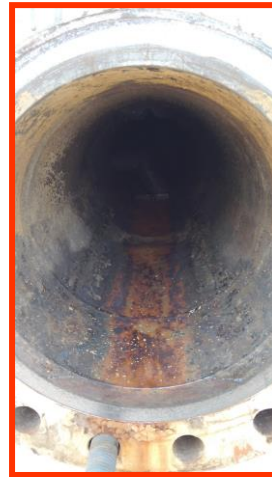
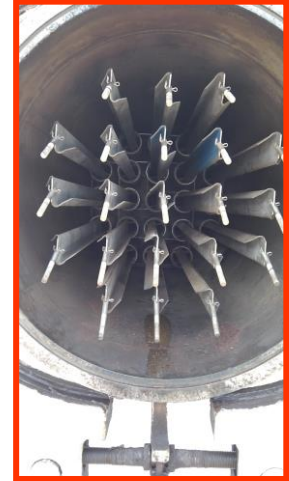
FILTER SEPARATORS

- Holding of tool box meeting among Global Calibration technicians, Bidi Group Technicians and WAPCo personnel was conducted.
- The first filter separator was opened and high pressure washing was conducted on its line to unclog them. The skid was cleaned later on.
- The second filter separator was opened and filters (which were fit to be reused) removed. High pressure washing was conducted on its lines, nipples and check valves to unclog them. The skid was cleaned.
- The gas scrubber having its gate difficult to open was opened after several hours. The team couldn't get enough time on it and began by removing debris at the door area. The debris was approximately about 10cm at the gate.

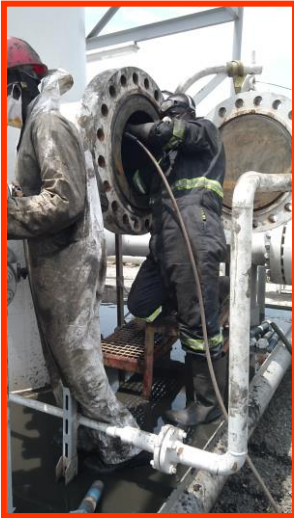
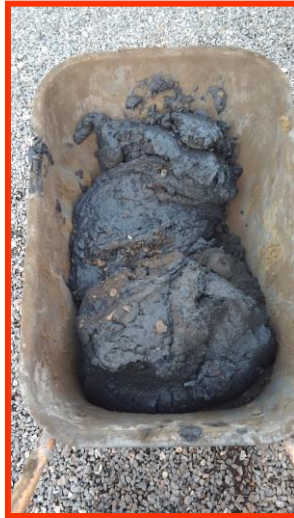
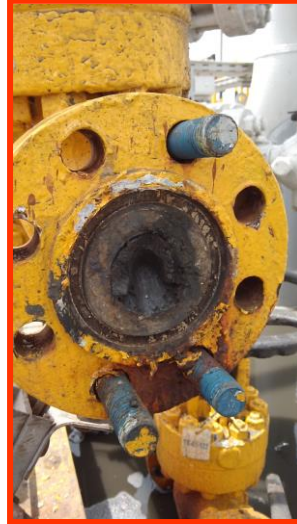
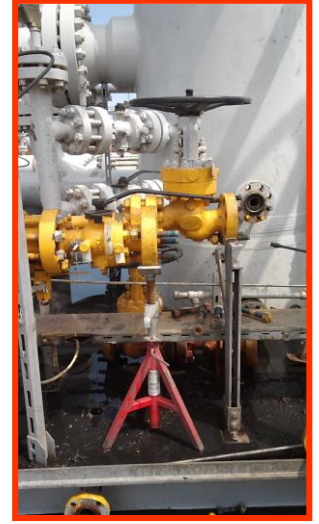
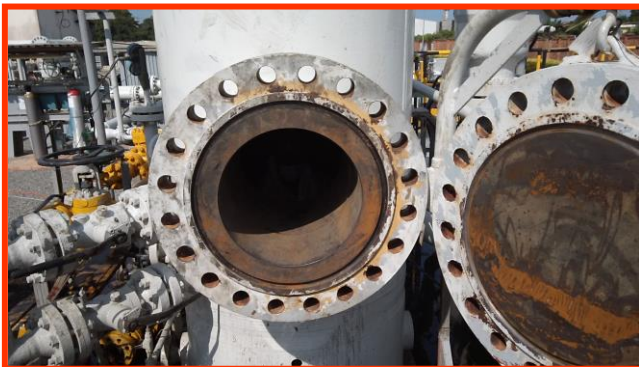
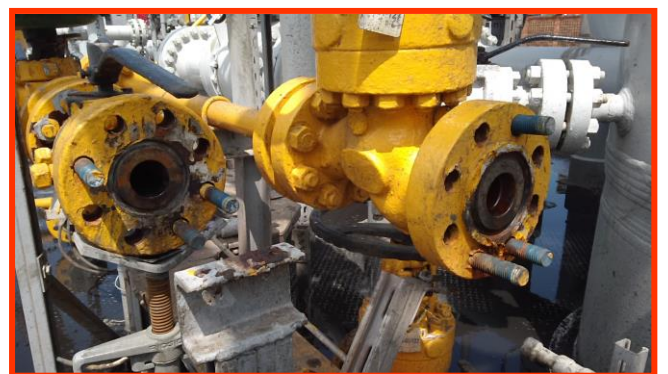
GAS SCRUBBER

- Holding of tool box meeting among Global Calibration technicians, Bidi Group Technicians and WAPCo personnel was conducted.
- The cleaning team began evacuation of sludge from the gas scrubber, using specially fabricated brass shovels.
- Technicians at some point had to enter the vessel to clear up had to reach debris. This activity was done as and when necessary with clearance from all three safety officials on site
- The Pressure washer was used to introduce the mixture of water and degreaser into the scrubber, to dislodge sludge that has settled on the tank walls. Clogging at the nipples, pipe elbows and check valves were cleared.

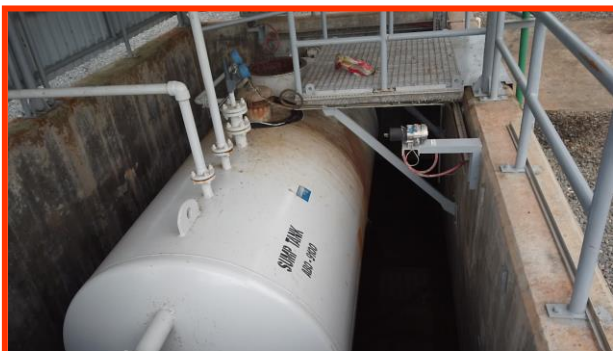
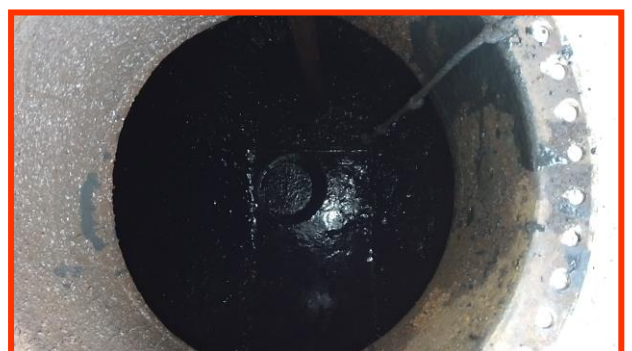
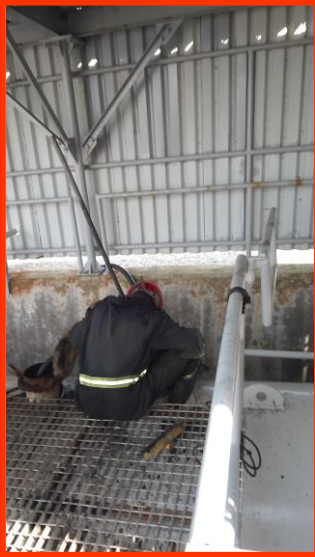
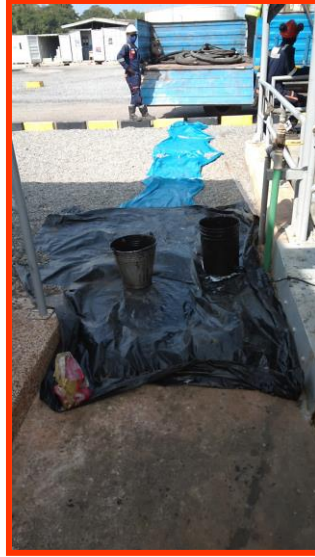
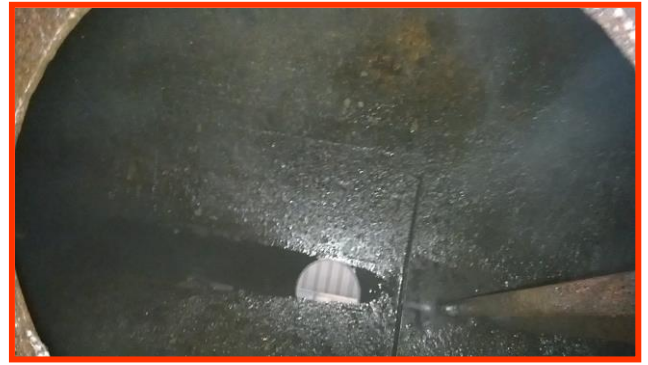
SUMP TANK

- The operation was completed and inspected and the skid cleaned up
- Zoil Technicians who were charged by Global Calibration arrived on site and joined forces with Bidi Group Technicians to evacuated sludge from the sludge tank.
- Specially fabricated shovels helped to fetch out sludge that couldn't be pumped out and the tank washed thoroughly with the Gamajet X and Pressure washer.
- The team cleared up the working area and packed all equipment into the truck for exit.
